Manual for Dismantling, Documenting and Rebuilding Historic Tiled Stoves

—Sustainable Heritage Report No. 3

A joint project between Gotland University, Estonian Academy of Arts
and Novia University of Applied Sciences.

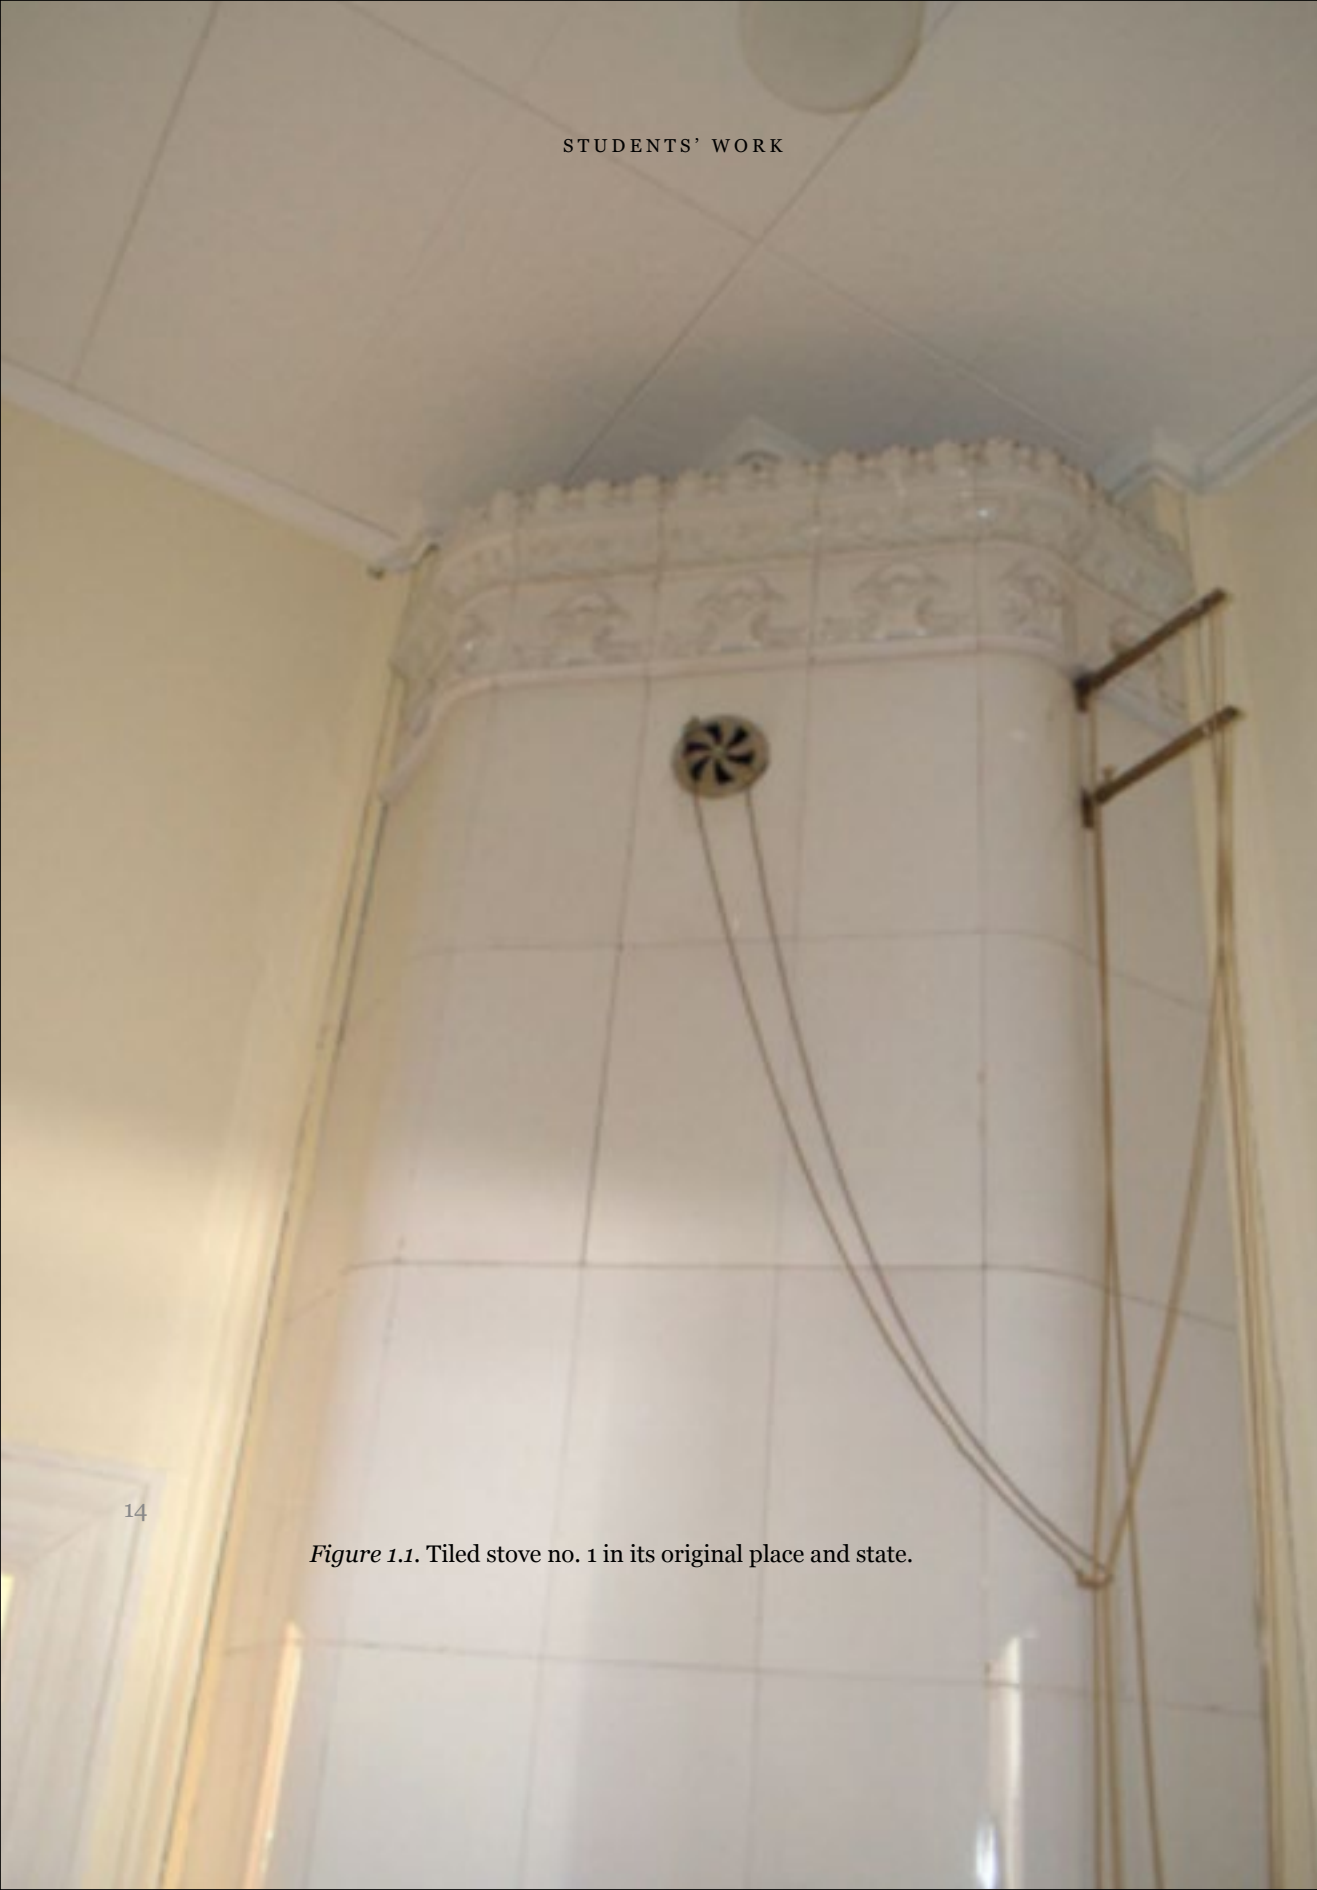
Figure 1.1. Tiled stove no. 1 in its original place and state.

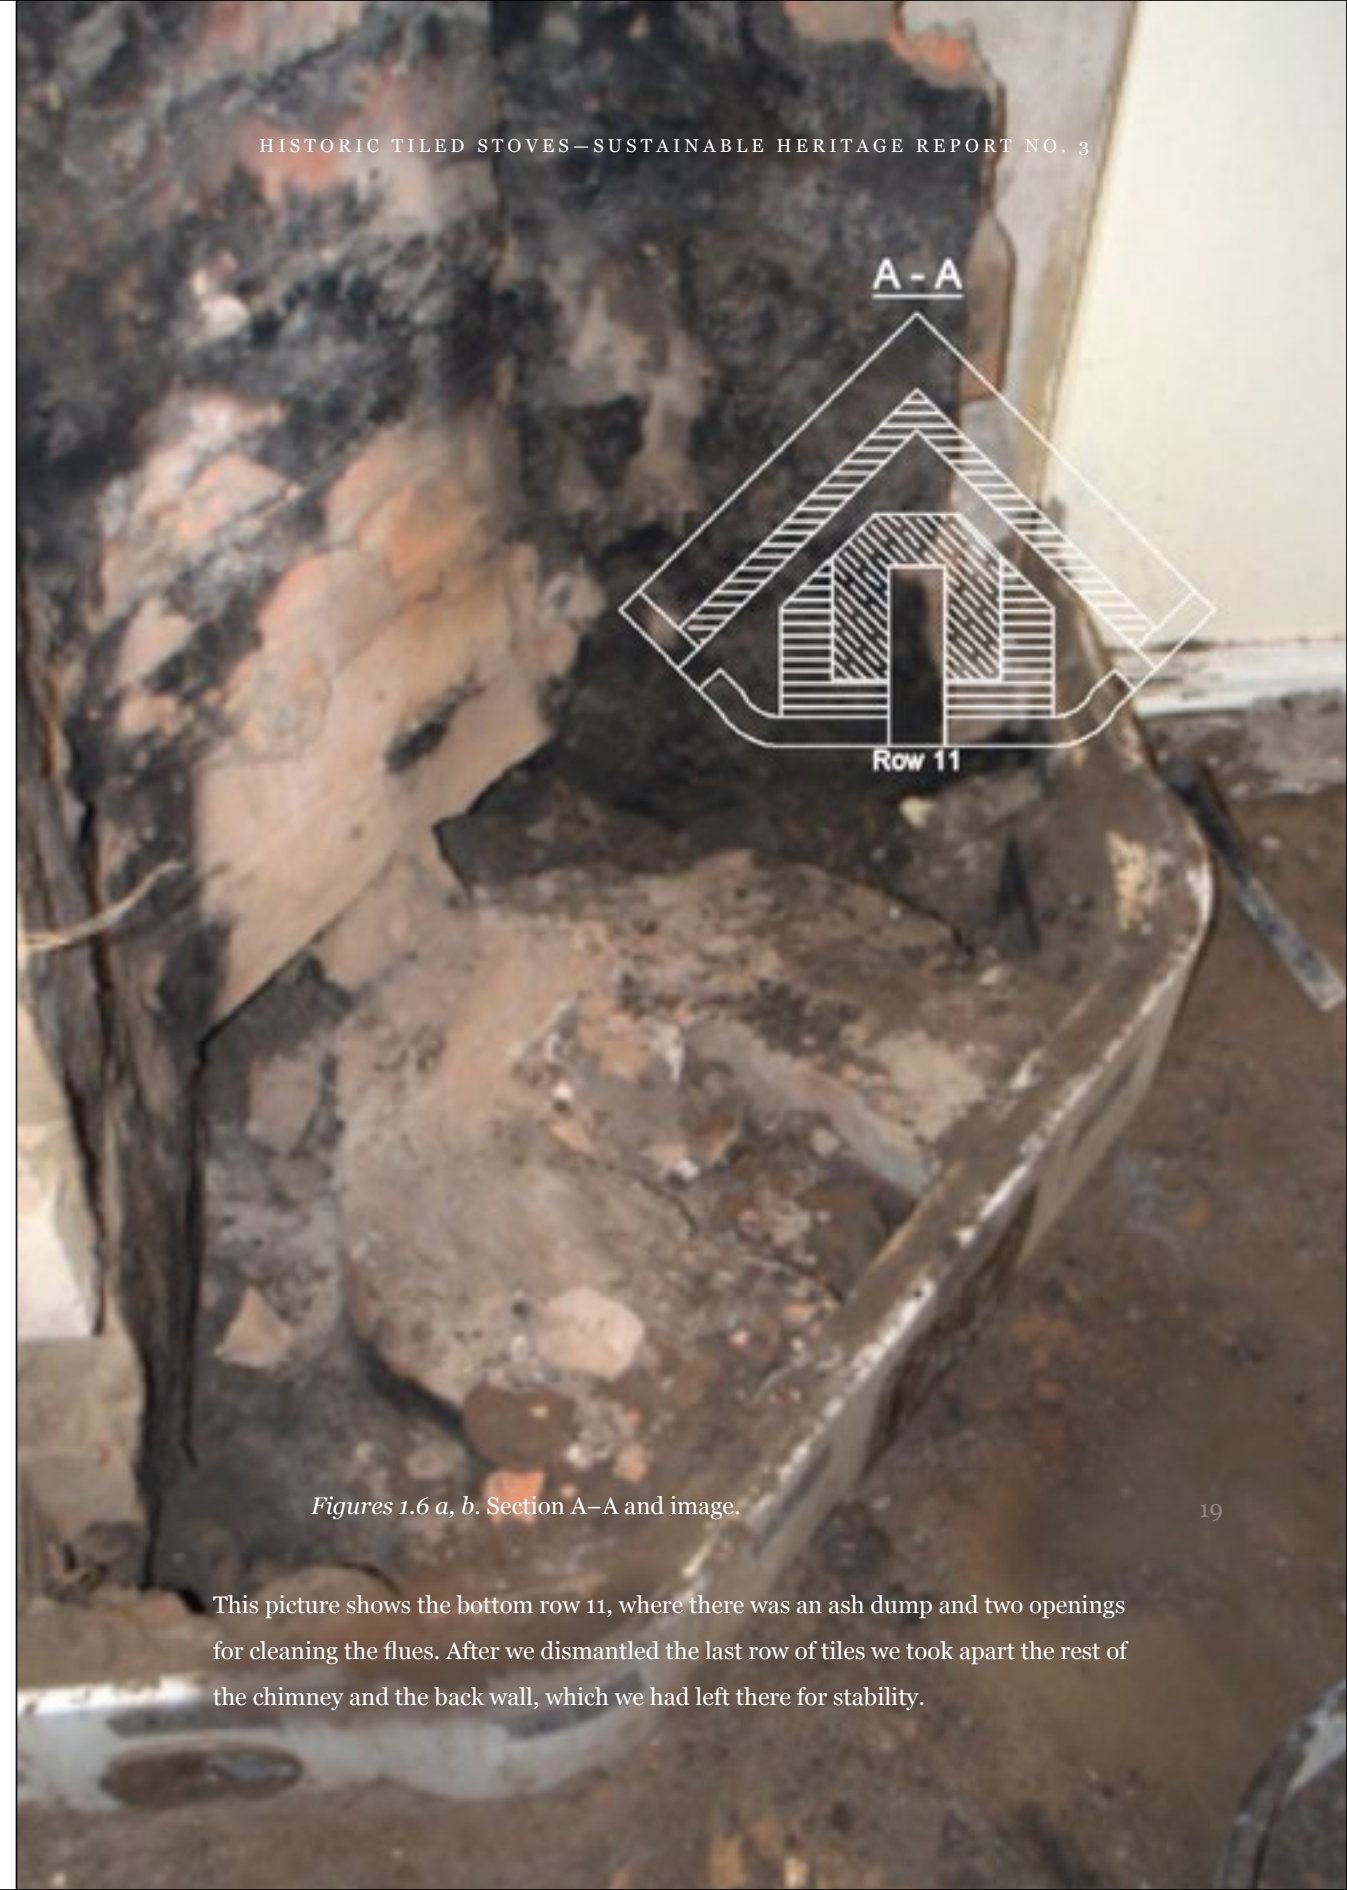
Figures 1.6 a, b. Section A-A and image.

This picture shows the bottom row 11, where there was an ash dump and two openings for cleaning the flues. After we dismantled the last row of tiles we took apart the rest of the chimney and the back wall, which we had left there for stability.

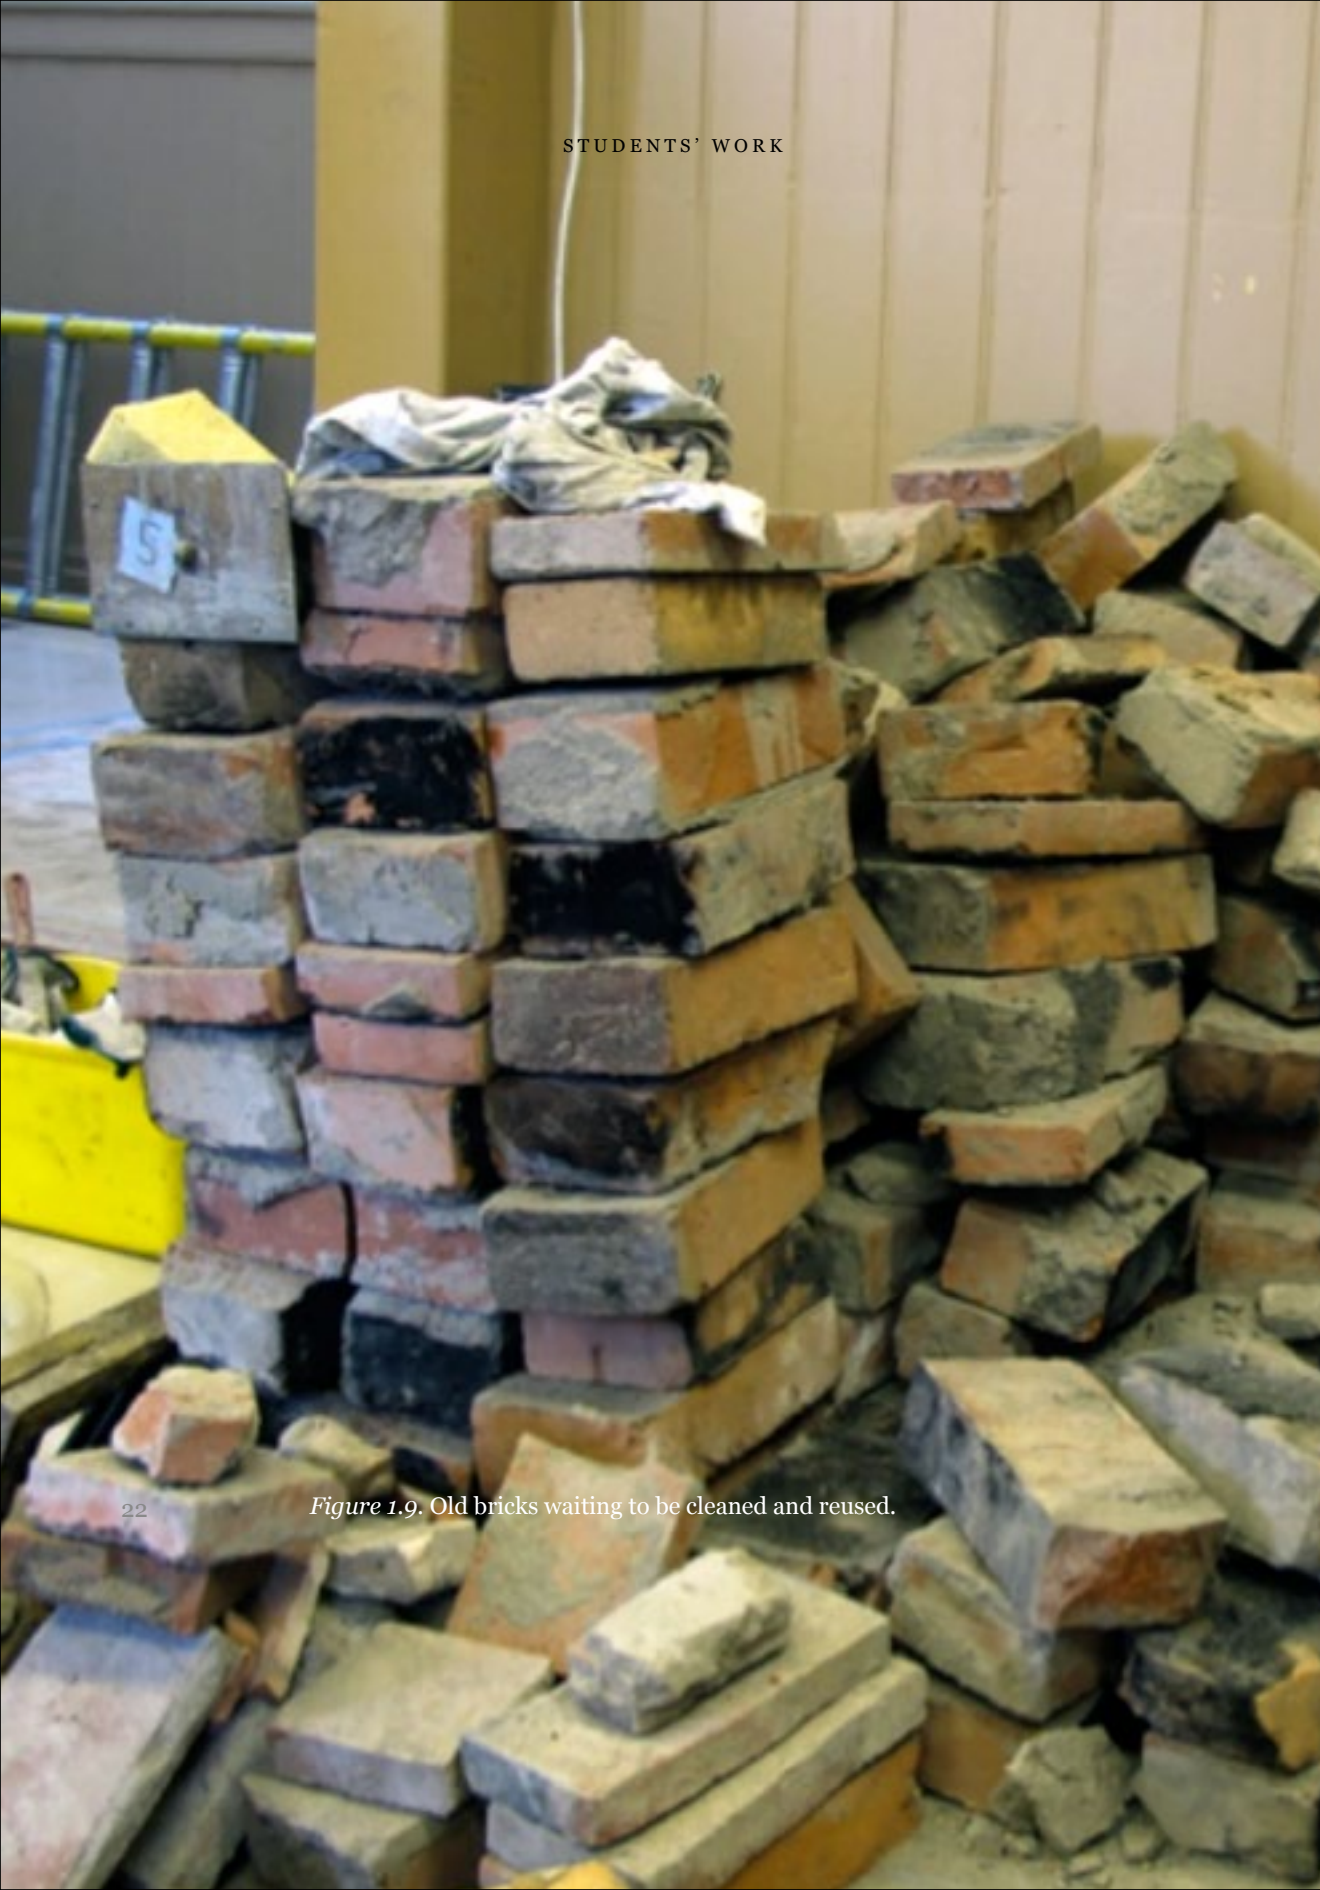
Figure 1.9. Old bricks waiting to be cleaned and reused.

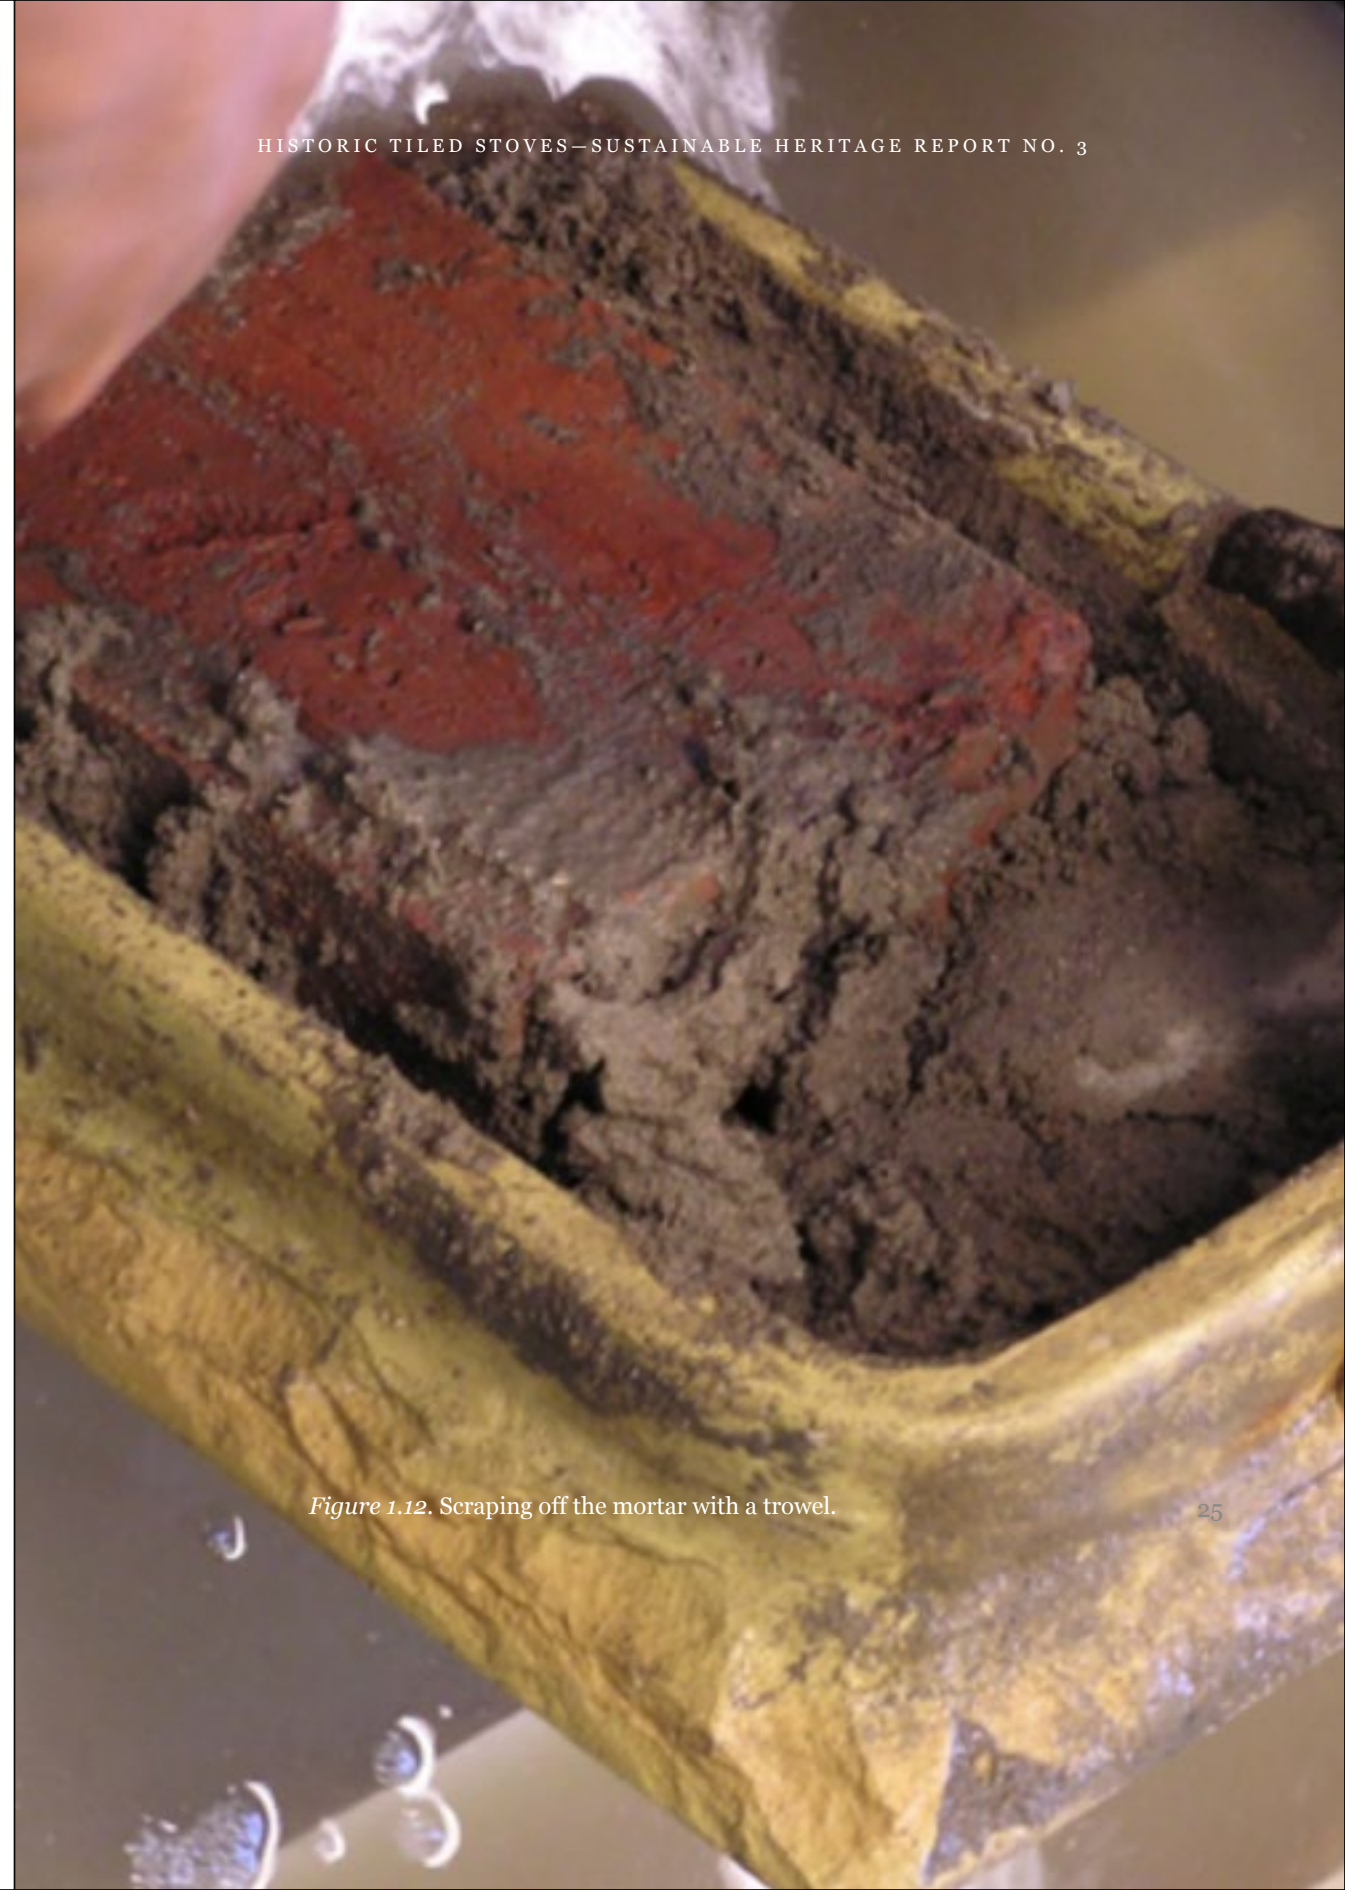
Figure 1.12. Scraping off the mortar with a trowel.

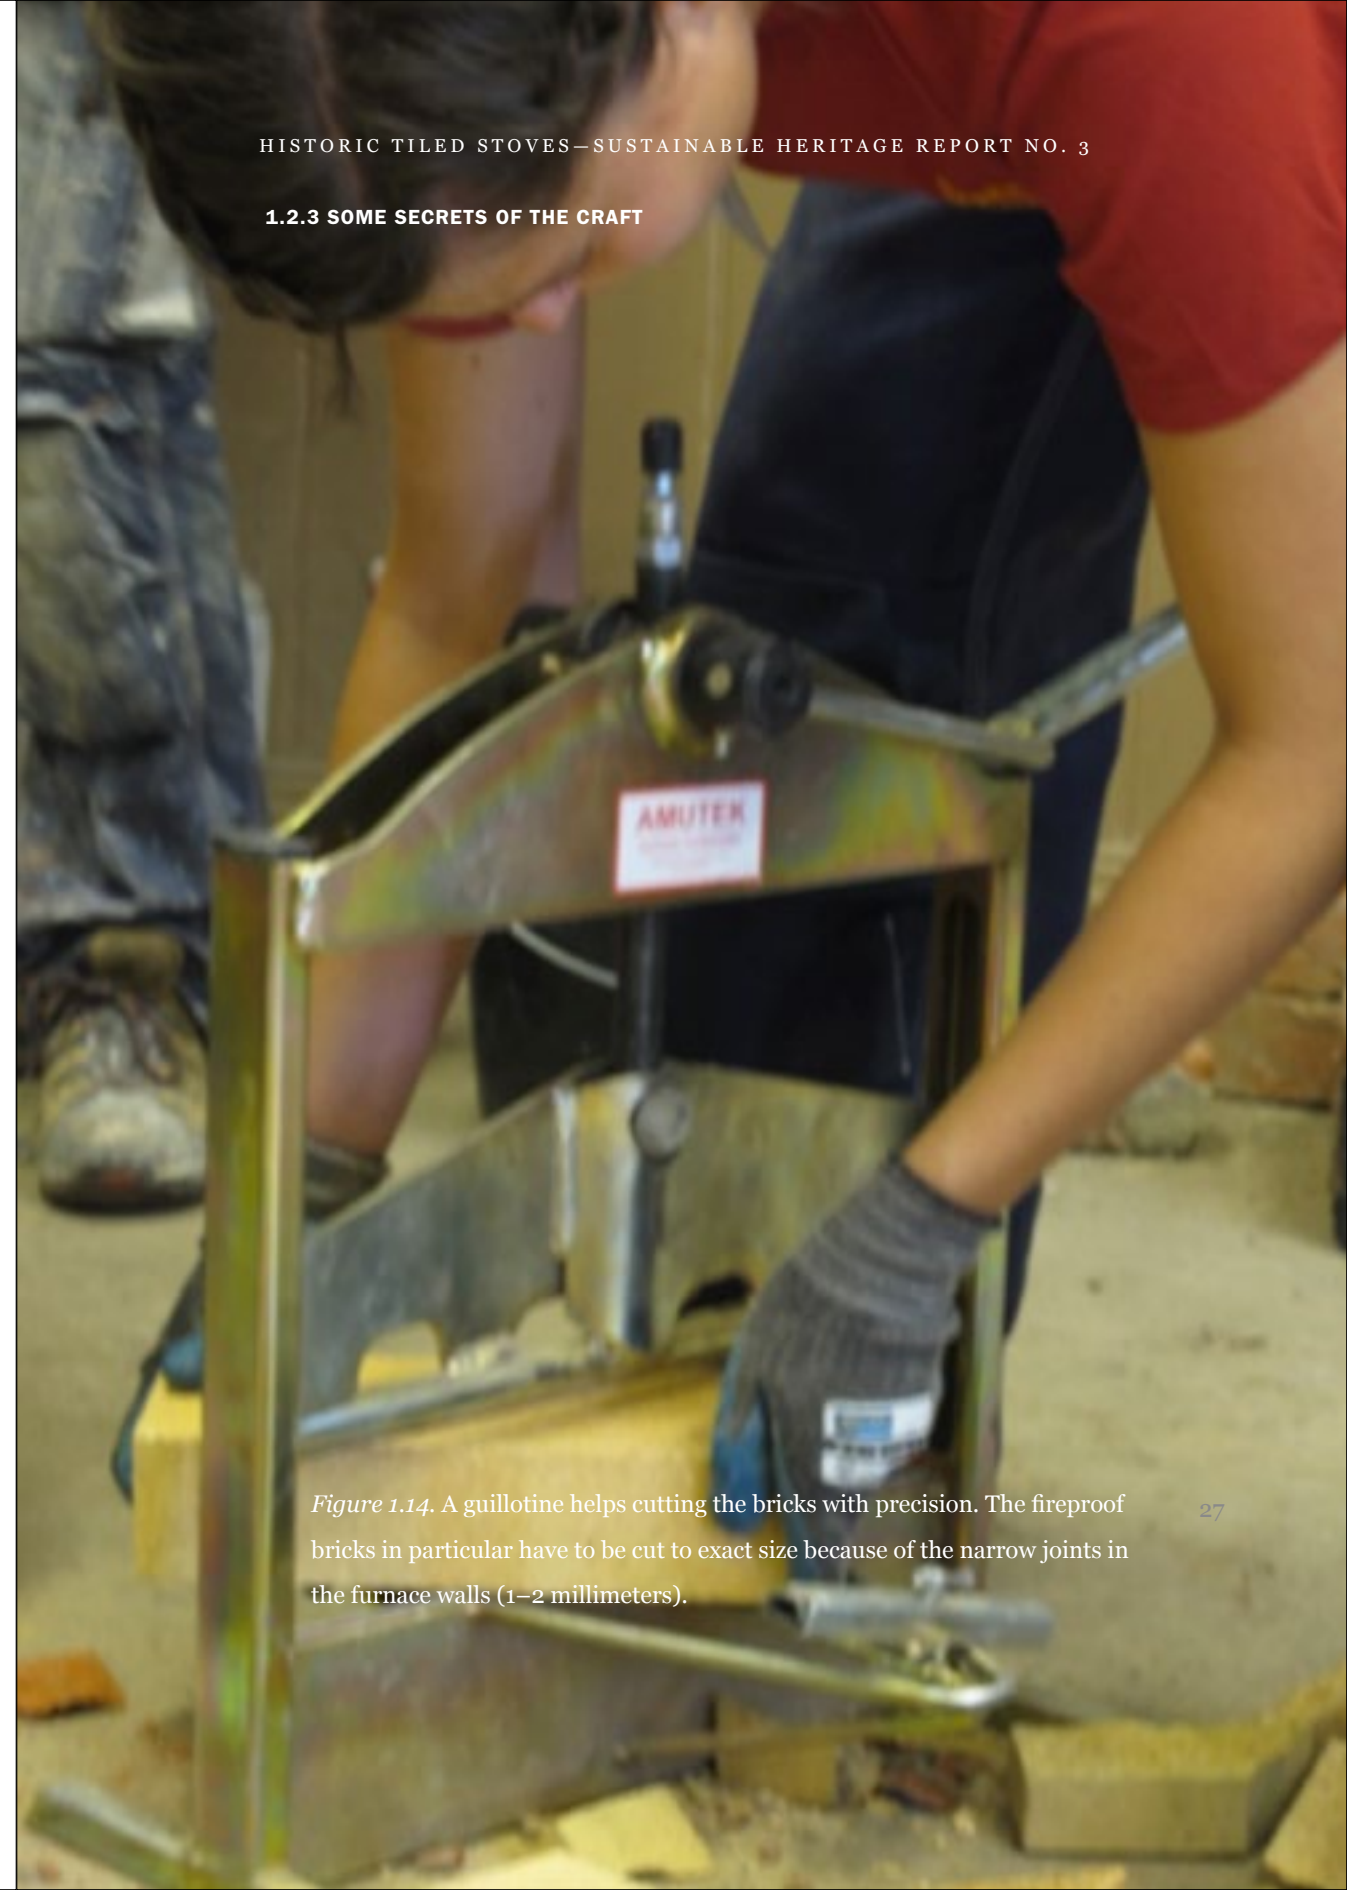
Figure 1.14. A guillotine helps cutting the bricks with precision. The fireproof bricks in particular have to be cut to exact size because of the narrow joints in the furnace walls (1–2 millimeters).

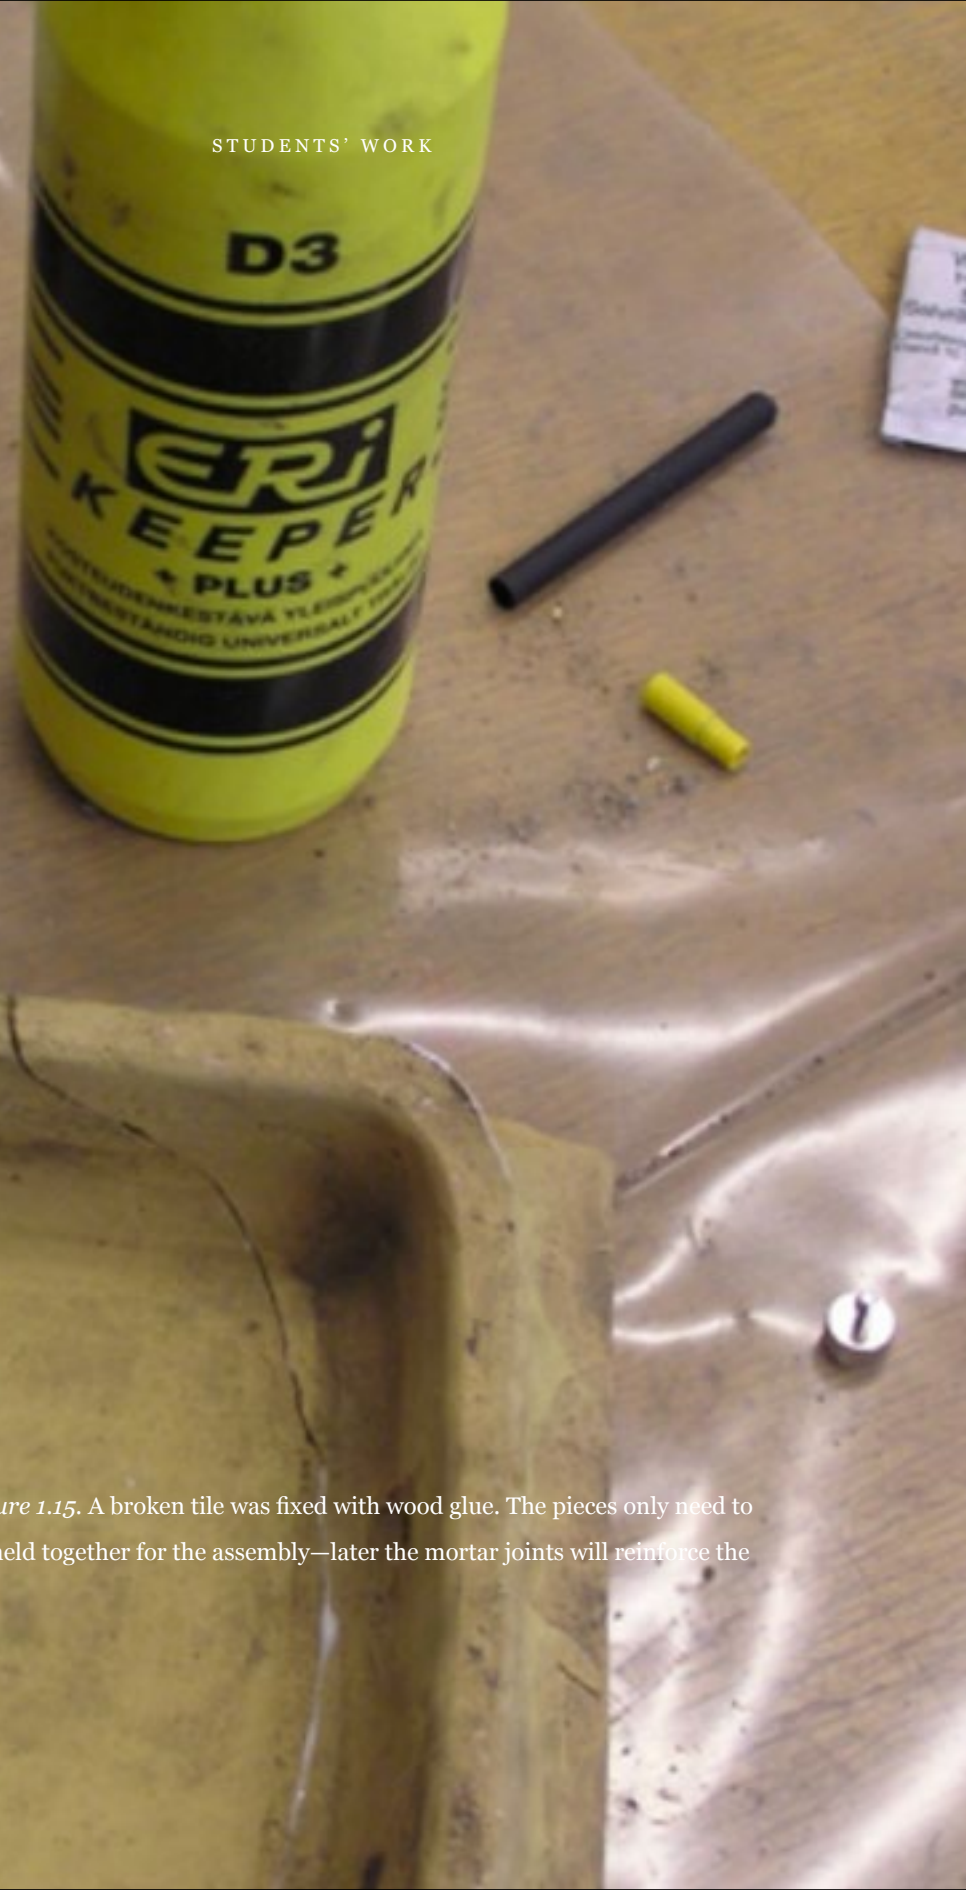
Figure 1.15. A broken tile was fixed with wood glue. The pieces only need to be held together for the assembly—later the mortar joints will reinforce the tile.

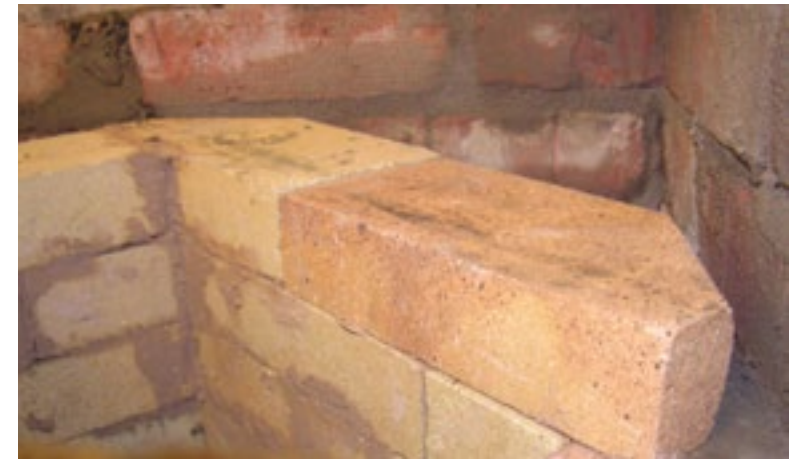
Figure 1.16. Fireproof bricks and mortar are used for the furnace. The bricks have to cover each cross-joint of the previous course.

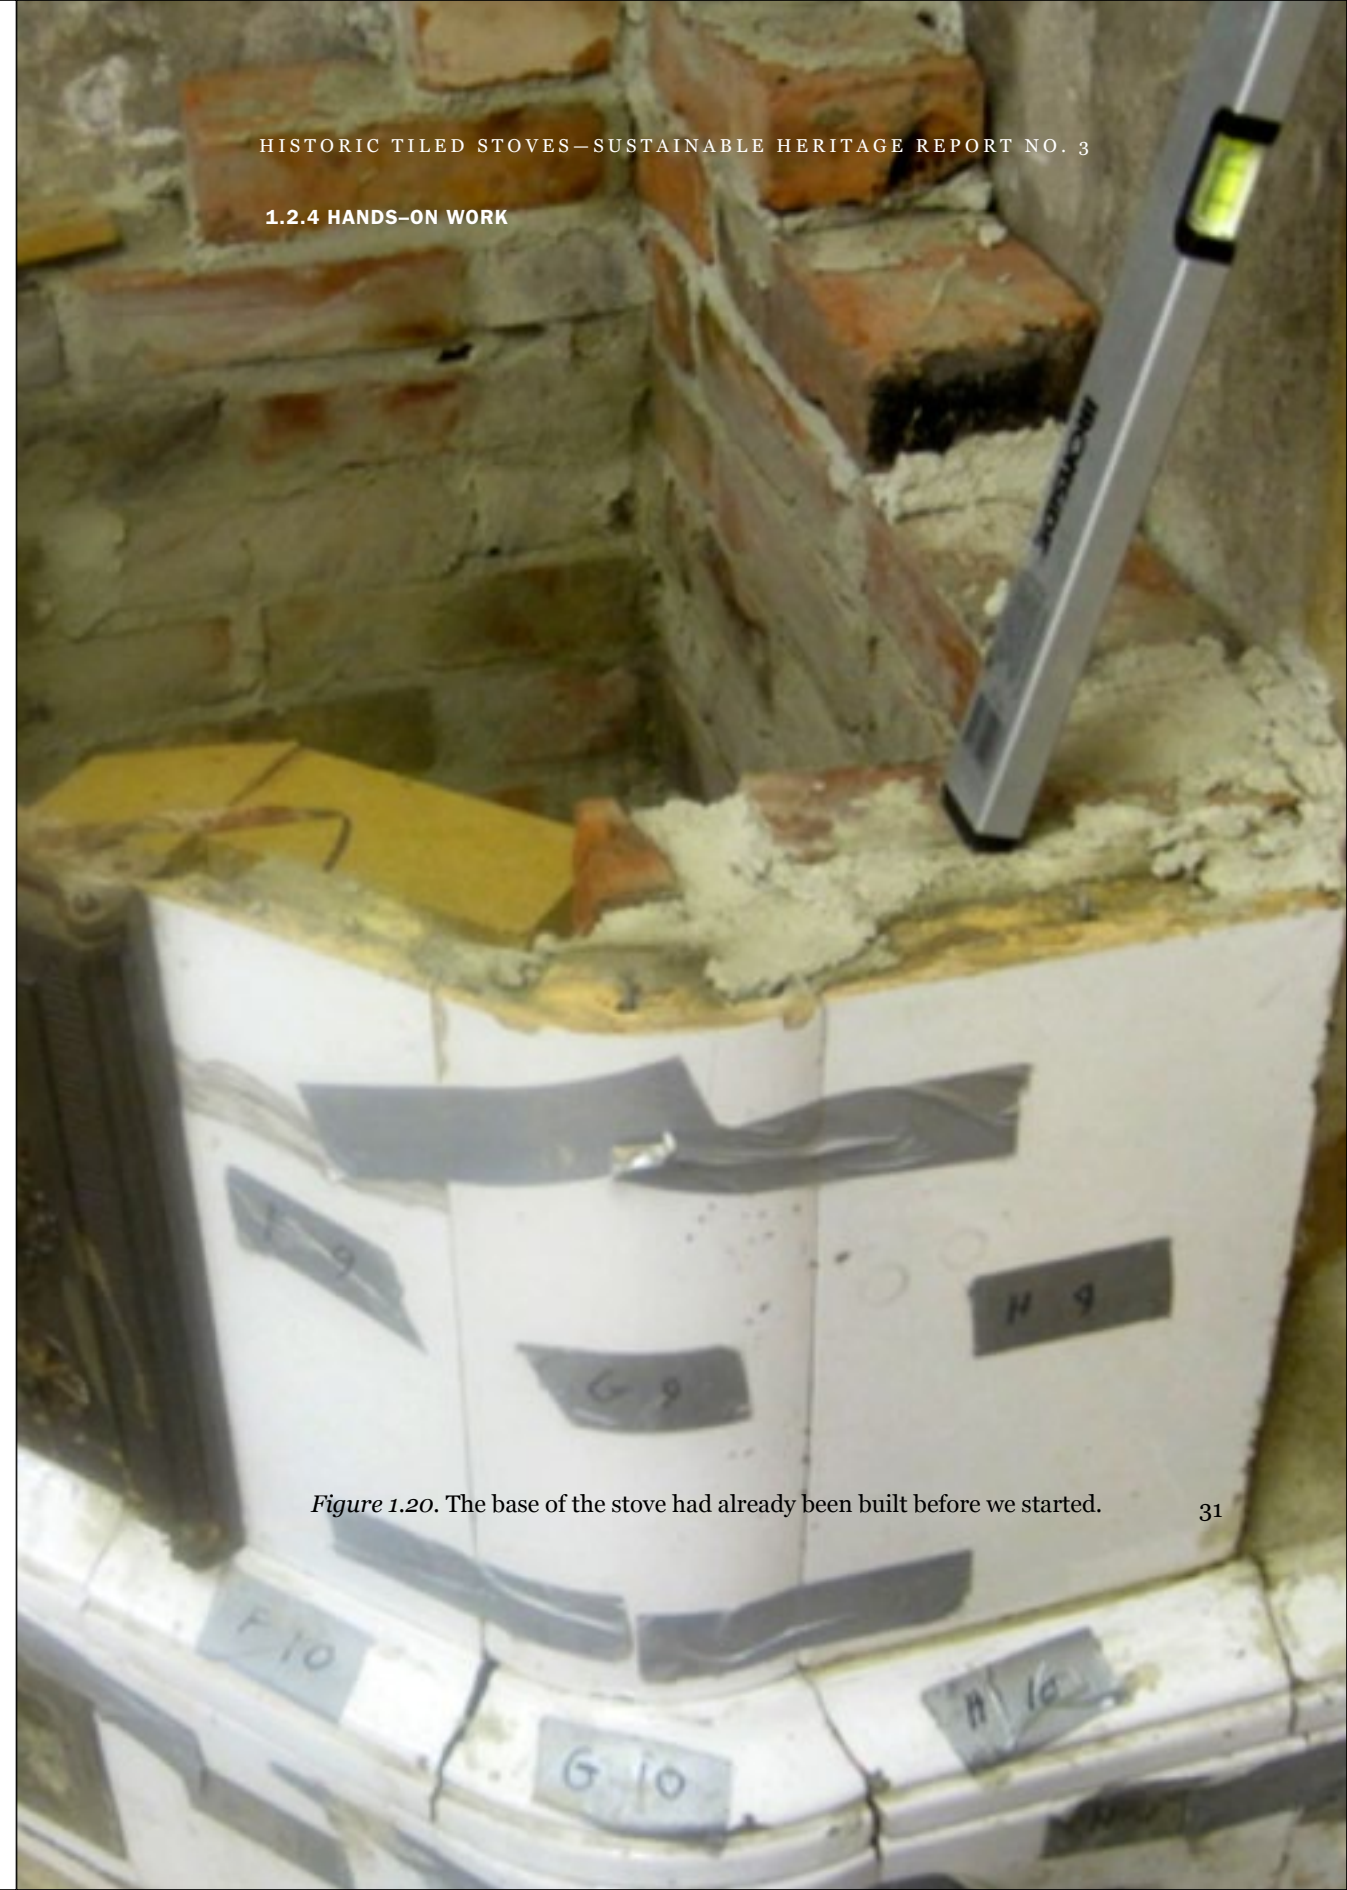
Figure 1.20. The base of the stove had already been built before we started.

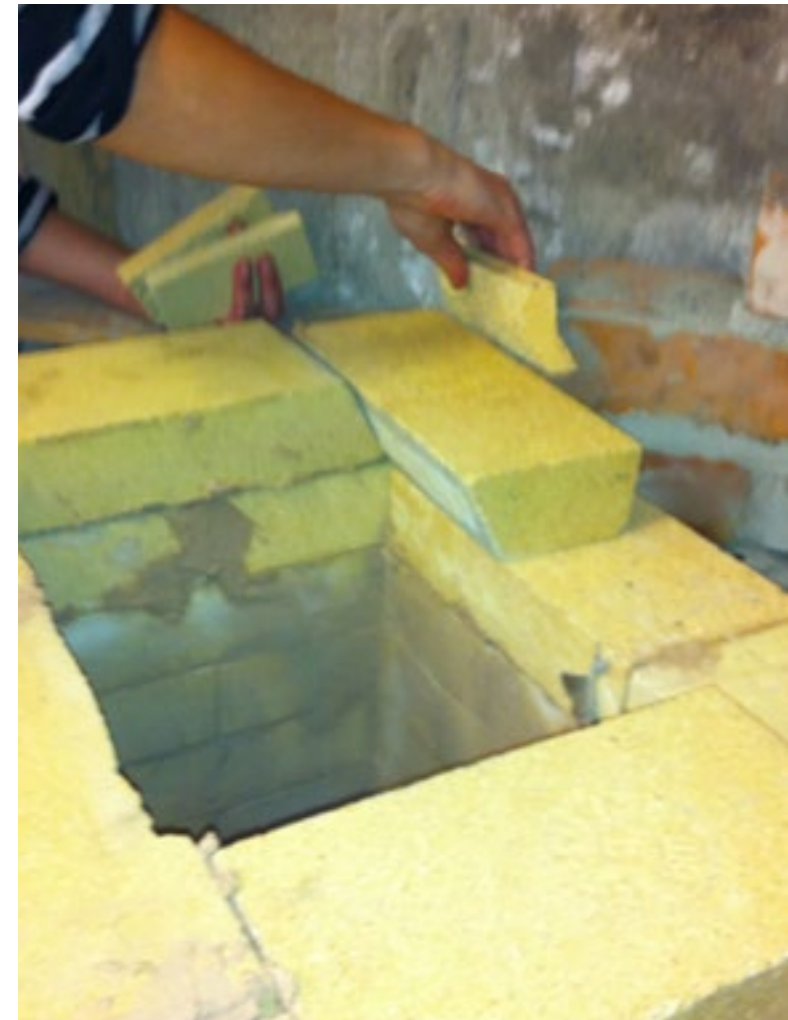
Figure 1.23. The rear masonry was laid to the height of half of the next tiles to be used as a support for the tiles.

The next step was to build the smoke flue upwards from the furnace. It was made narrower than the furnace. The bricks were sawn sidelong to narrow the canal from 420 x 355mm to 350 x 160mm. This is always done to create draught through the stove. Further up the flue is made wider again.

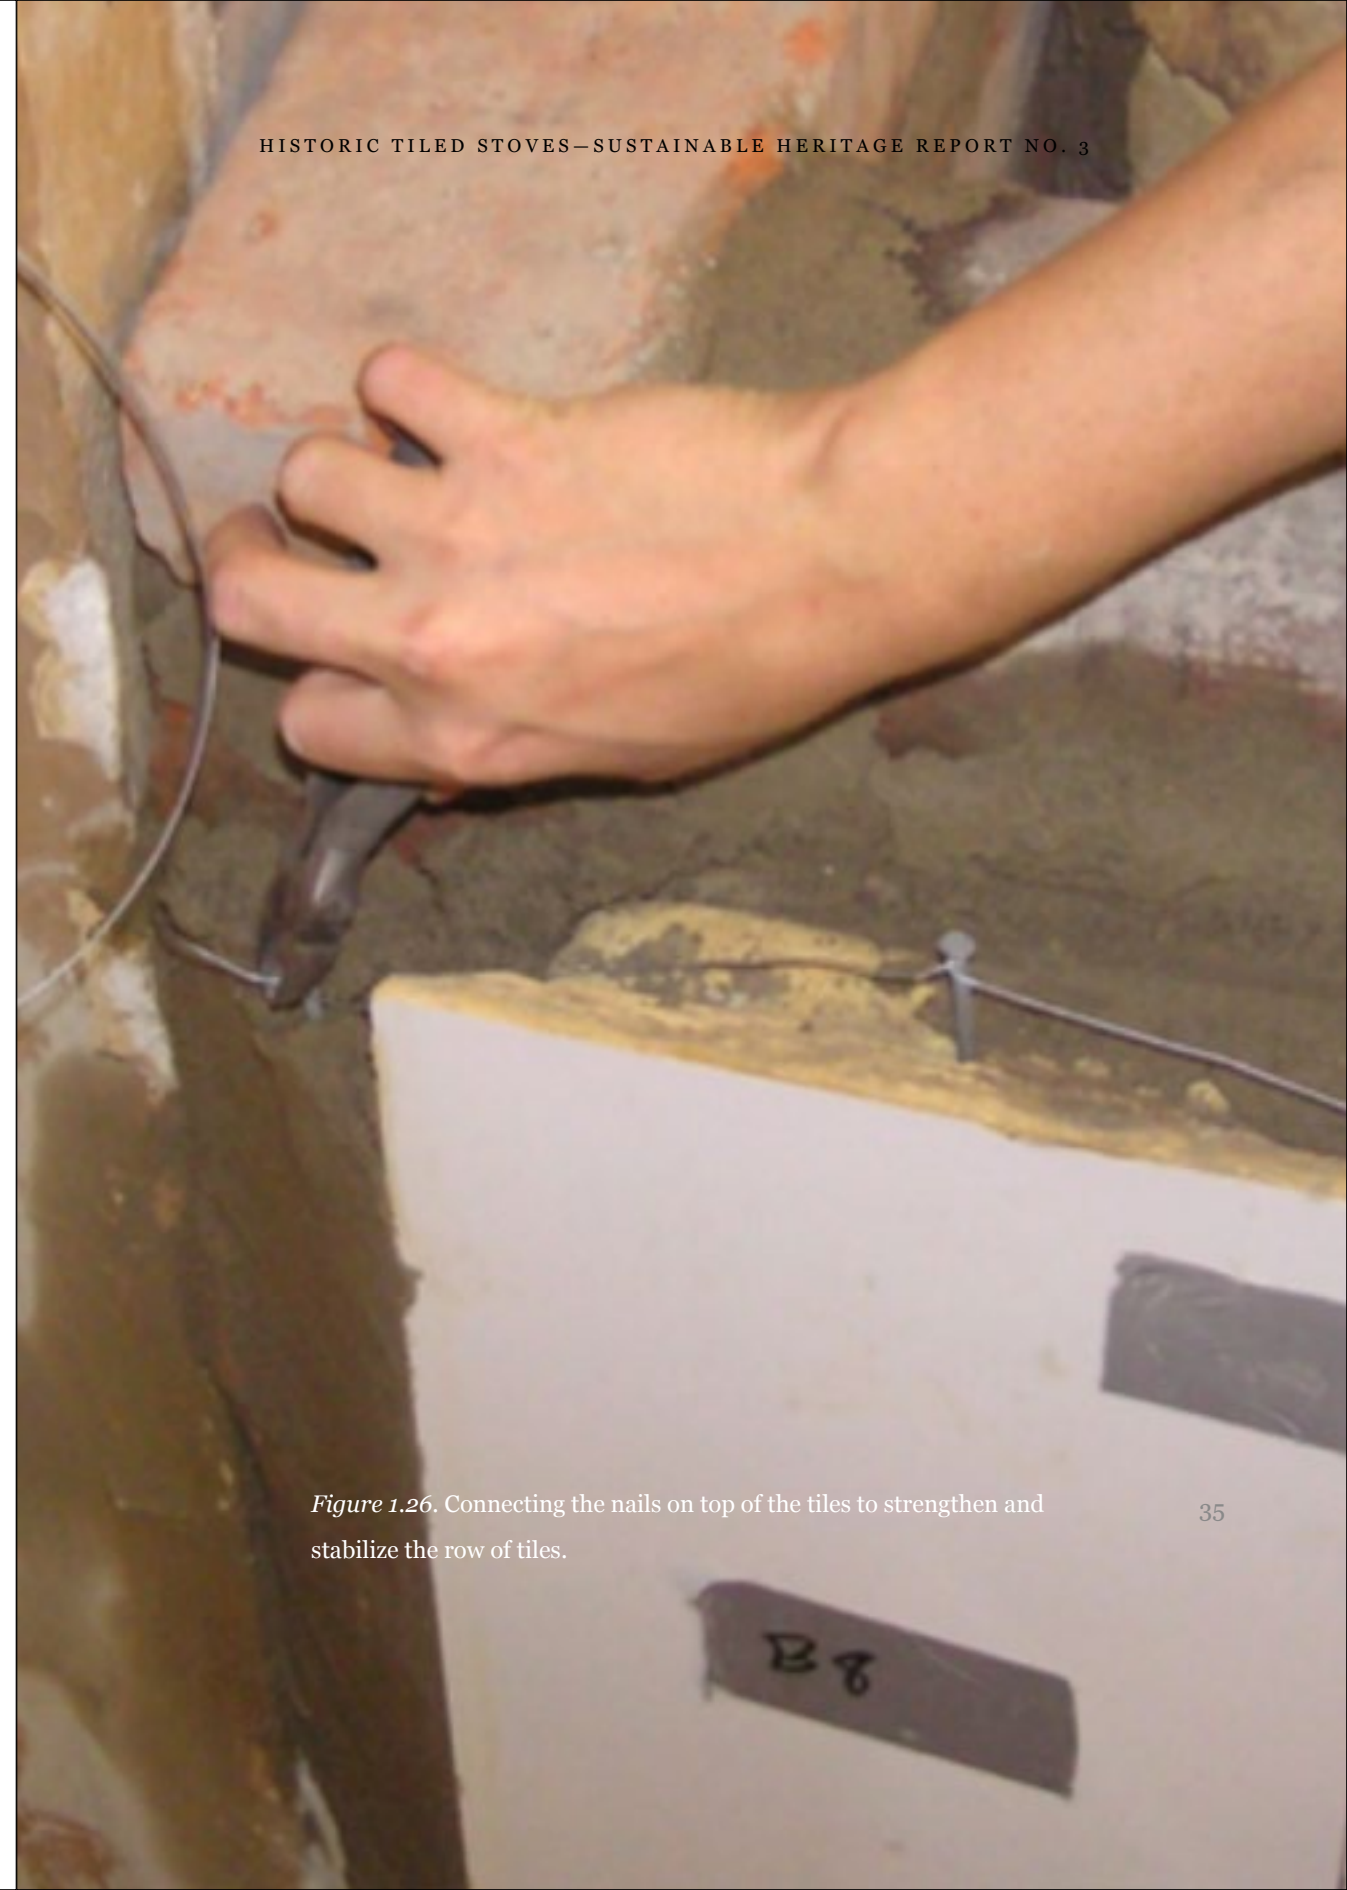
Figure 1.26. Connecting the nails on top of the tiles to strengthen and stabilize the row of tiles.
